RISO INC. **TECHNICAL INFORMATION BULLETIN**

Subject: New Style Drum PCB | Bulletin No: 38

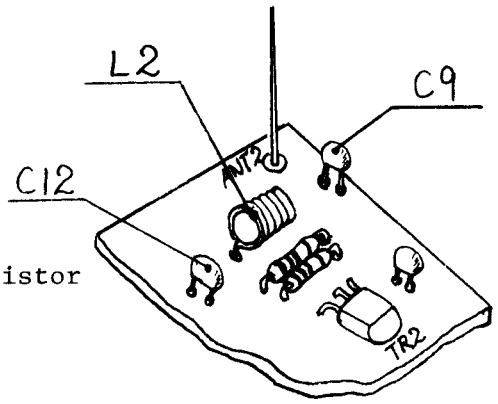
Problem: No Ink supplied to drum

Cause: 1) Bad solder connection on Ant-2
2) Position of coil L2
3) Antenna sensitivity

Problem: T4 too much ink supplied to drum

1) Antenna sensitivity

Correct

Incorrect

Check Solder

Solution: 1) Resolder Antenna
2) Reposition/reform L2, C9, C12
3) Replace R14 on drum PCB to 33KR Resistor

Solution: 1) Replace R14 drum PCB with 27KR resistor
2) Reposition/reform L1, C2, C5
